Manhole Inspection Summary

Manhole # S2100_013MH

Location Address: **2717 PARKWOOD-AUCHENTOROLY** Cross Street: **FULTON AVE**

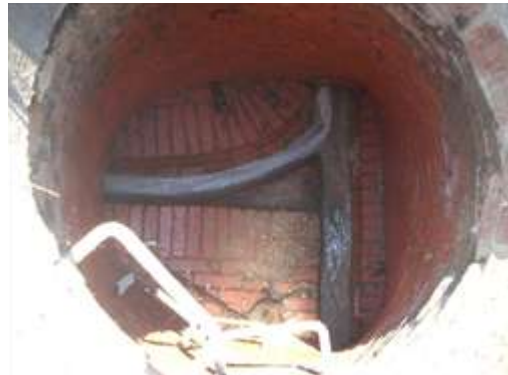
Top View

OFFSET CHANNEL. DEBRIS ON BENCH

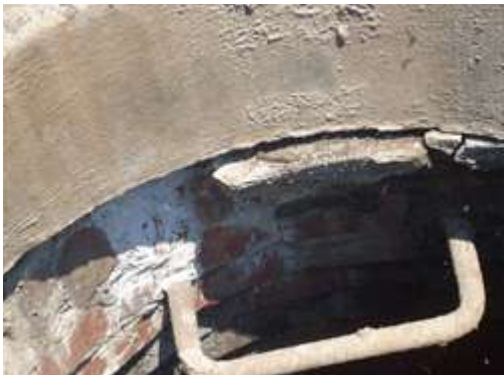
Defect 3

Chimney / Frame Adjustment ☒ Exists Material: **Concrete** ☐ Parged Height: **2** (in.)
Condition: ☐ Sound ☐ Cracked ☐ Root Intrusion ☐ Loose Brick ☒ **Deteriorated**
Infiltration: ☒ None ☐ Joint ☐ Cracks ☐ Mortar ☐ Roots ☐ Wall

DETERIORATION OF CHIMNEY

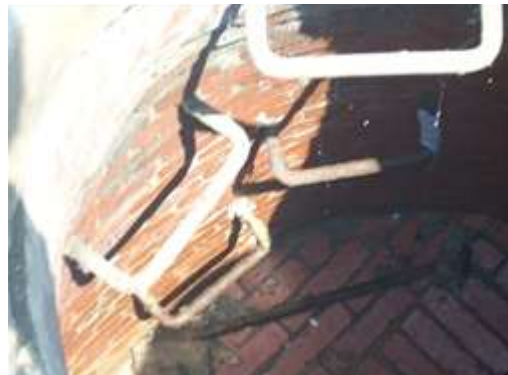
Defect 2

Steps Count: **5** Missing: **0** ☒ **Corroded**

CORRODED STEPS

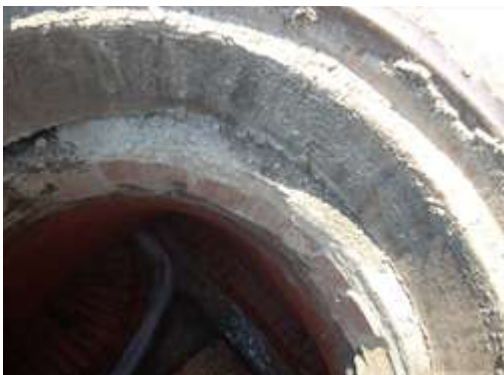
Defect 1

Frame Offset: **1** (in.) Condition: ☒ Sound ☐ Cracked ☐ Leaks

FRAME OFFSET

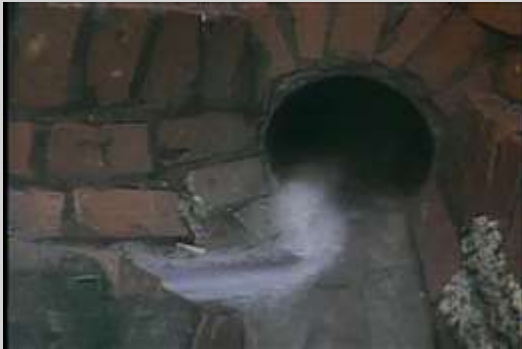
12 O'Clock Outflow

8 in. Circular Gravity Sewer
Pipe Out @ 12 O'Clock

Pipe Height: **7.2** (in.) Rod and Bar (Angled)
Pipe Material: **Clay** ☐ Pipe Lined
Invert Depth: **8.07** (ft.) Flow Characteristics: **Slow**
Deposits: ☒ None ☐ Mud ☐ Sludge ☐ Debris ☐ Grease
Silt Depth: (in.) Deposits Extent:
Infiltration: **None** Pipe Seal Cond: **Sound**

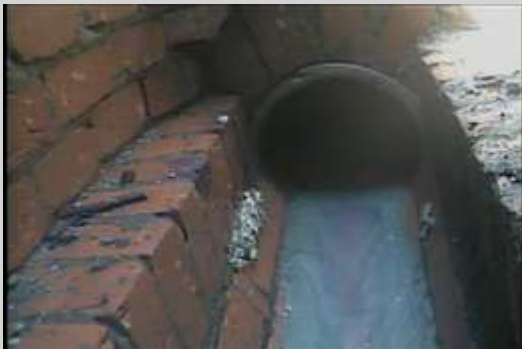
6 O'Clock Inflow

8 in. Circular Gravity Sewer
Pipe In @ 6 O'Clock

Pipe Height: **7.2** (in.) Rod and Bar (Angled)
Pipe Material: **Clay** ☐ Pipe Lined
Invert Depth: **7.95** (ft.) Flow Characteristics: **Slow**
Deposits: ☒ None ☐ Mud ☐ Sludge ☐ Debris ☐ Grease
Silt Depth: (in.) Deposits Extent:
Infiltration: **None** Pipe Seal Cond: **Sound**

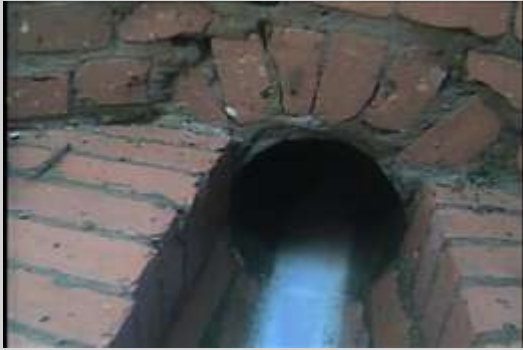
9 O'Clock Inflow

Pipe Height: **8.4** (in.) Rod and Bar (Angled)

Pipe Material: **Clay** ☐ Pipe Lined

Invert Depth: **7.50** (ft.) Flow Characteristics: **Slow**

Deposits: ☒ None ☐ Mud ☐ Sludge ☐ Debris ☐ Grease

Infiltration: **None** Pipe Seal Cond: **Sound**
